Case Study: 44 Martin Place, Sydney NSW

01 Project Summary

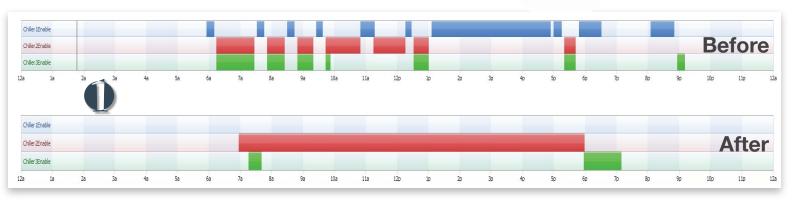
Out of hours chiller operation

Incorrect chiller startup sequence

The most recent discovery relates to the chiller startup sequence being incorrect, with the Hi-load chiller starting prior to the others. Addressing this aided in additional energy savings.
